# **INDOOR AIR QUALITY ASSESSMENT**

**Wachusett Regional High School  
1401 Main Street  
Holden, Massachusetts 01520**

Prepared by:  
Massachusetts Department of Public Health  
Center for Environmental Health  
Emergency Response/Indoor Air Quality Program  
November 2005

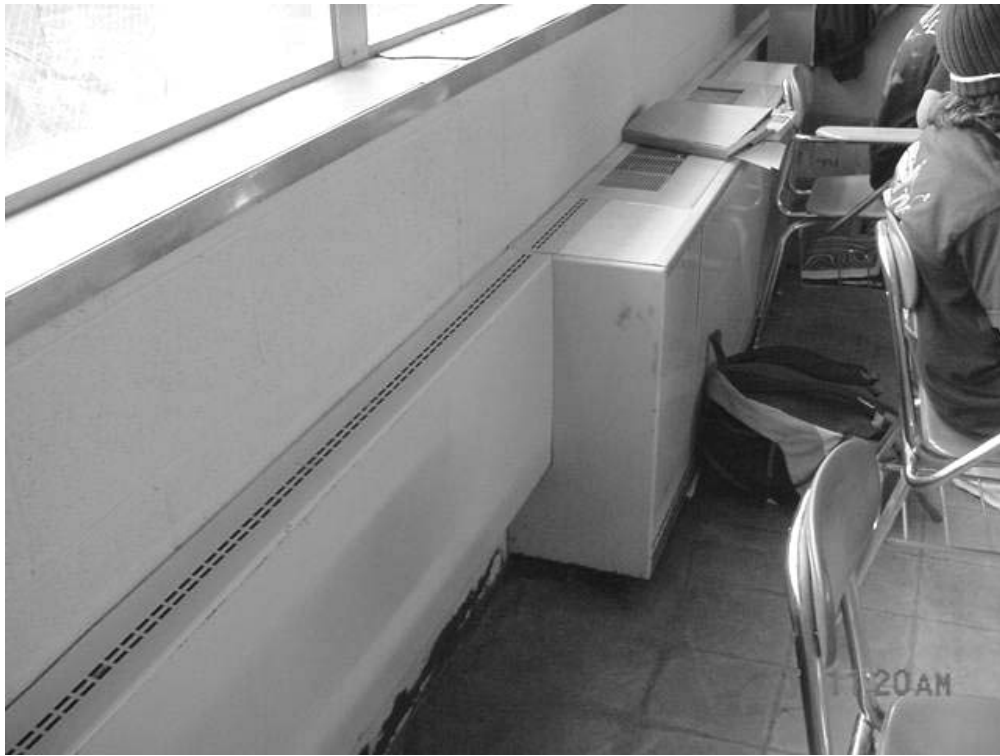
**Picture 1**

classrooms is provided by unit ventilator (univent) systems (Picture 1). A univent draws air from outdoors through a fresh air intake located on the exterior wall of the building (Picture 2) and returns air through an air intake located at the unit's base. Fresh and return air are mixed, filtered, heated and provided to classrooms through an air diffuser located in the top of the unit ([Figure 1](#)).

Although univents were activated, airflow was weak. Univents appear to be original equipment, approximately 50 or more years old. Function of such aged equipment is difficult to maintain, since compatible replacement parts are often unavailable. Airflow was also impeded by filter media installed over the air intakes on the exterior of the building (Picture 2). The filter media was installed in an effort to reduce/prevent the entrainment of construction related pollutants generated from activities adjacent to the building (Pictures 3 and 4).

**Classroom Univent in Lower Level Classroom, Circa 1950**

2. Operate all ventilation systems (that are operable) throughout the building (e.g., gym, auditorium, classrooms) continuously during periods of school occupancy to maximize air exchange. Continue with plans to make repairs to mechanical ventilation components in the lower level.

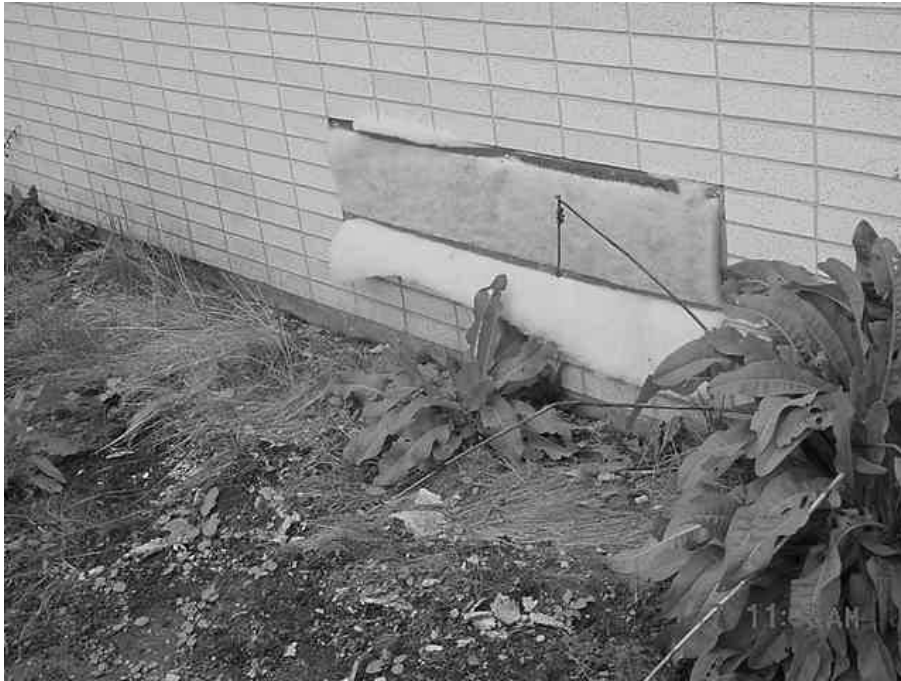
**Picture 2**

**Univent Air Intake for Lower Level Classroom Covered with Filter Media**

18. Consider changing HVAC filters more regularly in areas impacted by renovation activities. Examine the feasibility of acquiring more efficient filters for these units.

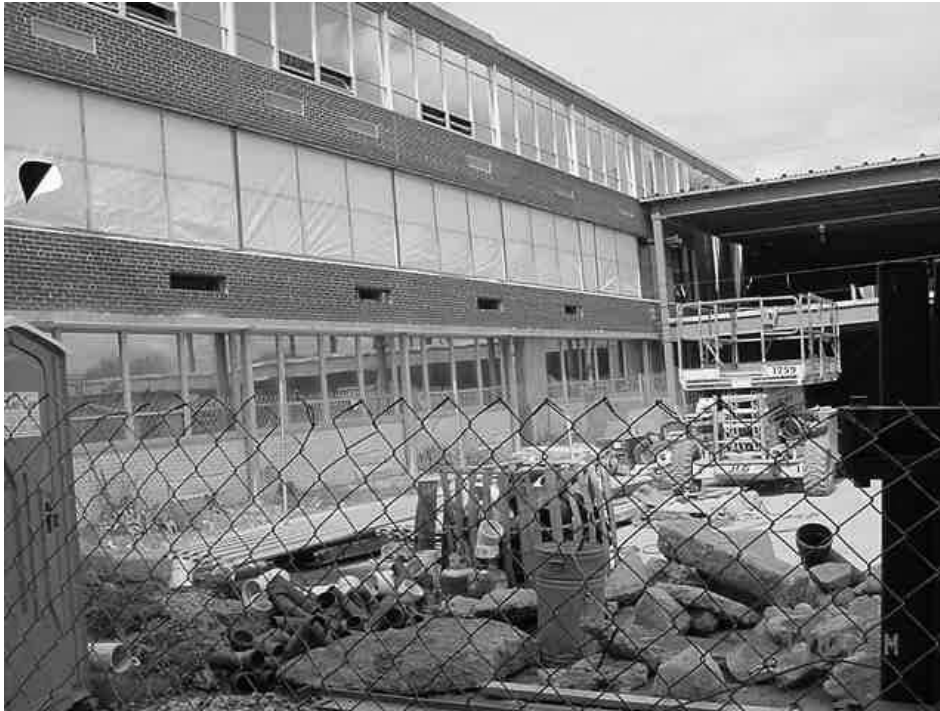
**Picture 3**

**Construction Activity Adjacent to Lower Level Classrooms**

13. Ensure the faculty is aware of construction activities that may be conducted in close proximity to their classrooms. In certain cases, HVAC equipment and windows to classrooms adjacent to construction activities may need to be deactivated/closed periodically to prevent unfiltered air and vehicle exhaust from entering the building. For this reason, prior notification(s) should be made.

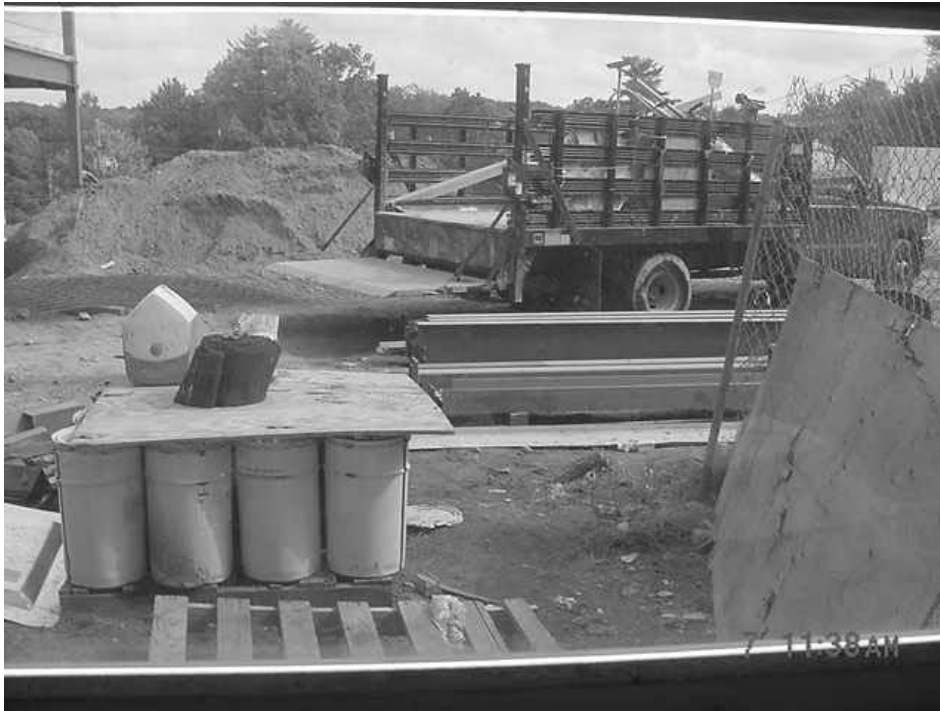
**Picture 4**

**Construction Activity Adjacent to Lower Level Classrooms, Picture Taken from Inside Classroom**

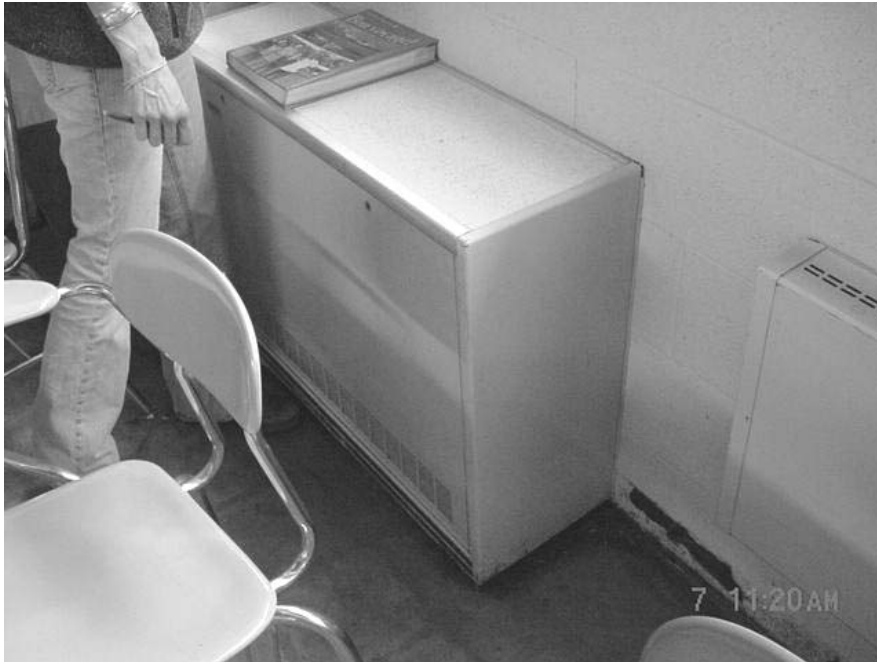
**Picture 5**

Exhaust ventilation in lower level classrooms was designed to be provided by unit exhaust ventilators (Picture 5), which are much like a univent but *remove air* from the building. A unit exhaust ventilator contains a fan, which draws in and forces air out through an exhaust vent on the exterior of the building. All unit exhaust ventilators were deactivated during the assessment and appeared not to have been operated for some time. Exhaust ventilation in classroom 207 was originally provided by exhaust vents located in an ungrated "cubby hole" located at floor level (Picture 6). Classroom air is drawn into the cubby hole and vented to a rooftop motor. As with the unit exhaust ventilators, this exhaust was inoperable at the time of the assessment. Therefore, no mechanical exhaust was being provided to these classroom areas.

**Unit Exhaust Ventilator in Lower Level Classroom**

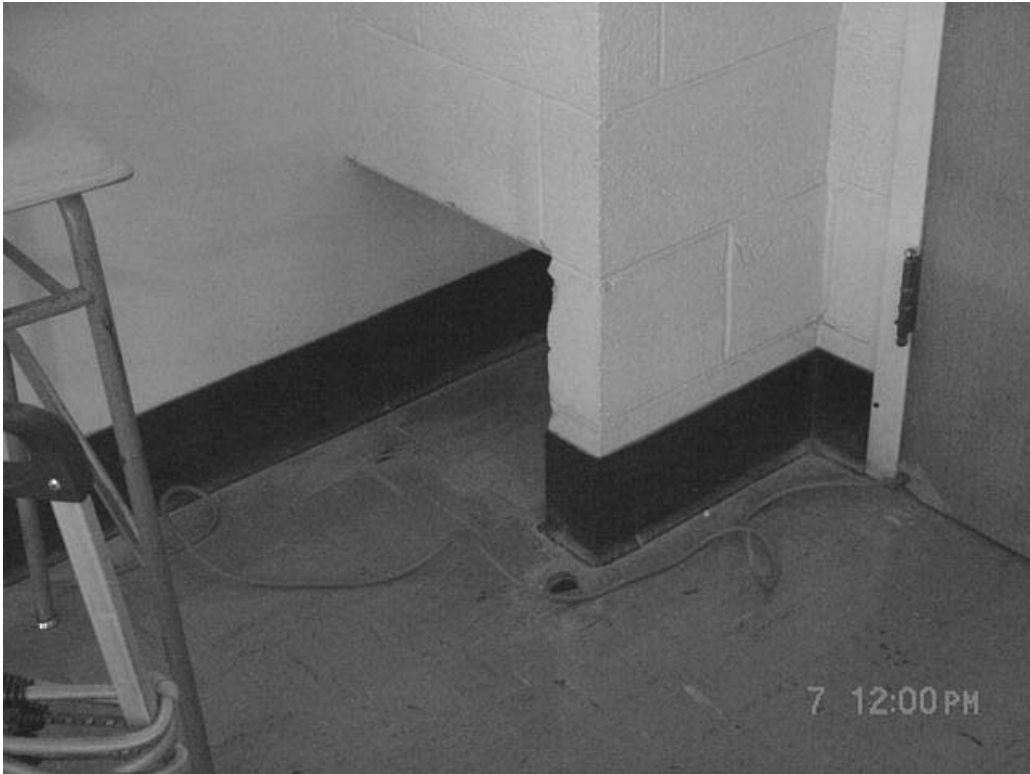
**Picture 6**

**Exhaust Cubby for Classroom 207**

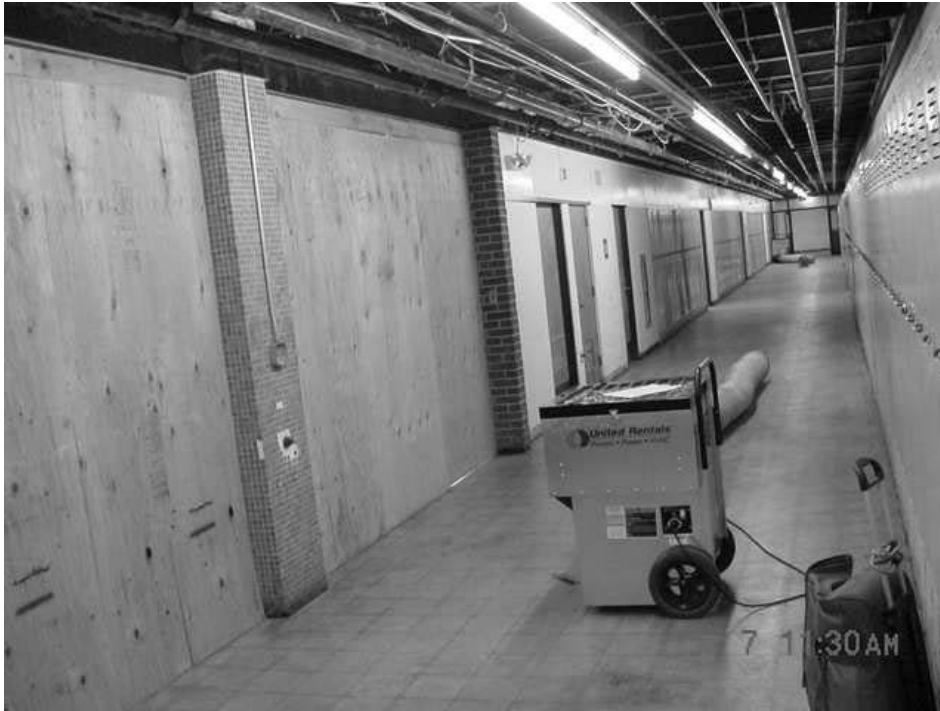
**Picture 7**

In an effort to reduce airborne pollutants generated by adjacent construction, air filtration units equipped with high efficiency particulate arrestance (HEPA) filters were employed in the lower level hallway (Picture 7). However, the filtration unit was actually *drawing* construction-generated pollutants *into* the building through gaps/spaces in the construction containment wall (Pictures 8 and 9). As with the lower level construction barrier, breaches were observed in and around several other barriers from which drafts could be felt and/or light could be seen (Table 2).

**HEPA Filtration Unit in Lower Level Hallway, Note Flexible Ductwork Forcing Air *towards* Classrooms**

8. Use local exhaust ventilation and isolation techniques to control for renovation pollutants. Precautions should be taken to avoid the *re-entrainment* of these materials into the building's HVAC system. The design of each system must be assessed to determine how it may be impacted by renovation activities. Specific HVAC protection requirements pertain to the return, central filtration and supply components of the ventilation system. This may entail shutting down systems (when possible) during periods of heavy construction and demolition, ensuring systems are isolated from contaminated environments, sealing ventilation openings with plastic and utilizing filters with a higher dust spot efficiency where needed (SMACNA, 1995).

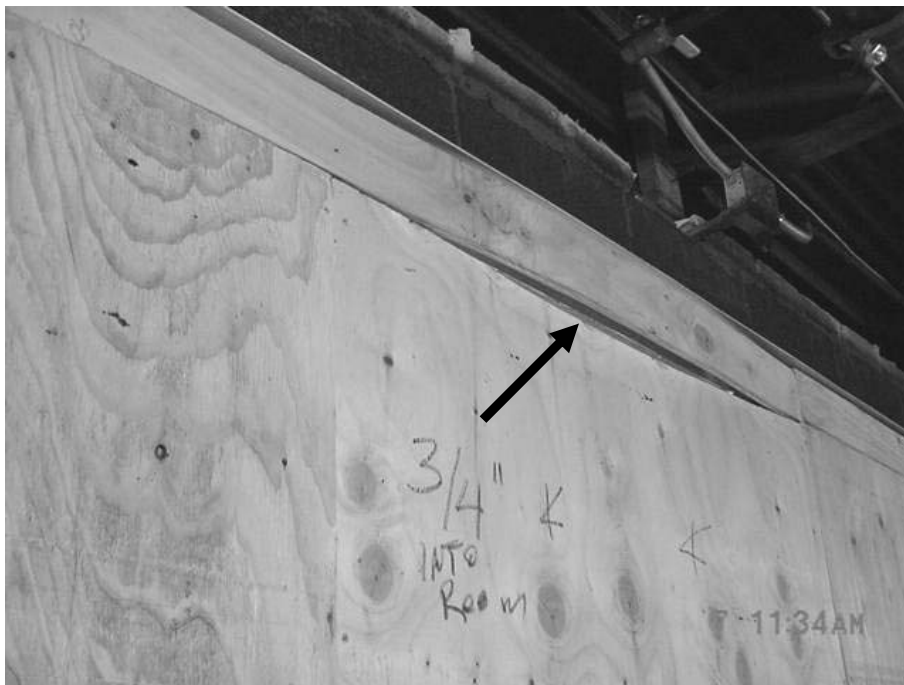
**Picture 8**

**Breach in Construction Containment Wall in Lower Level Hallway**

4. Seal around exterior doors with weather stripping and door sweeps. Seal construction barriers on all sides with polyethylene plastic and duct tape. Seal these barriers on the construction as well as the occupied side to provide a dual barrier. Ensure integrity of barriers by monitoring for light penetration and drafts around seams.

5. Inspect classrooms for cleanliness and construction barriers for integrity *daily* prior to the opening of school. Consideration should also be given to inspect construction barriers at the end of the school day prior to construction work. In addition, encourage school staff to report any breaches in construction barriers immediately to the main office during the school day.

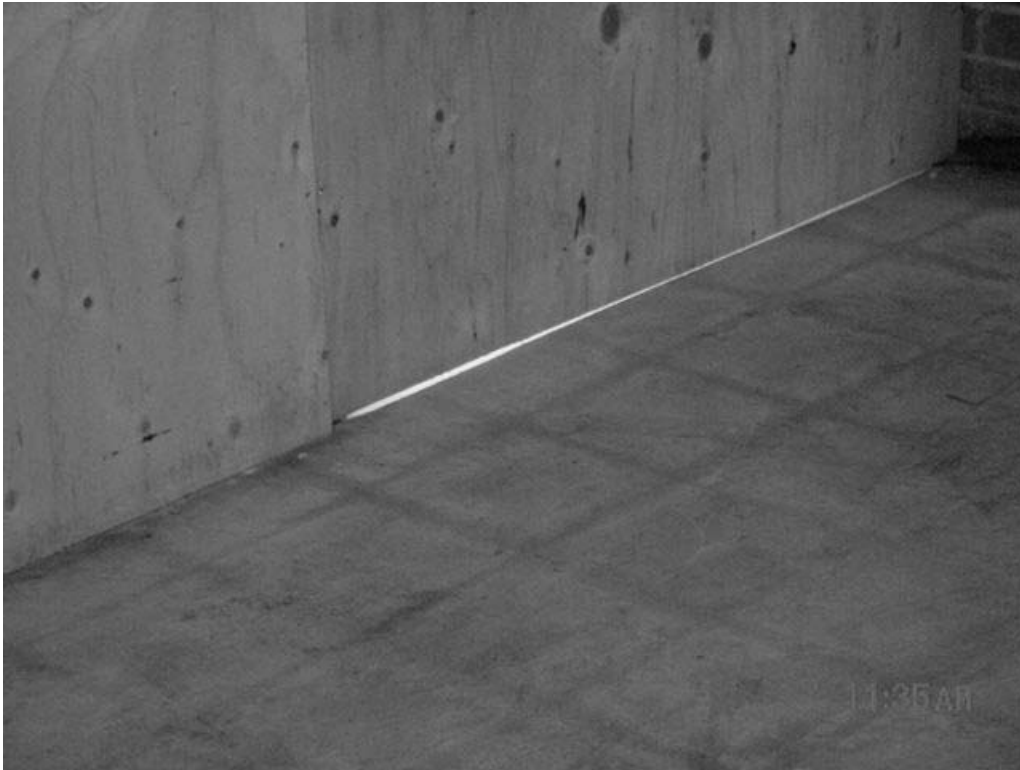
**Picture 9**

**Space beneath Construction Containment Wall in Lower Level Hallway**

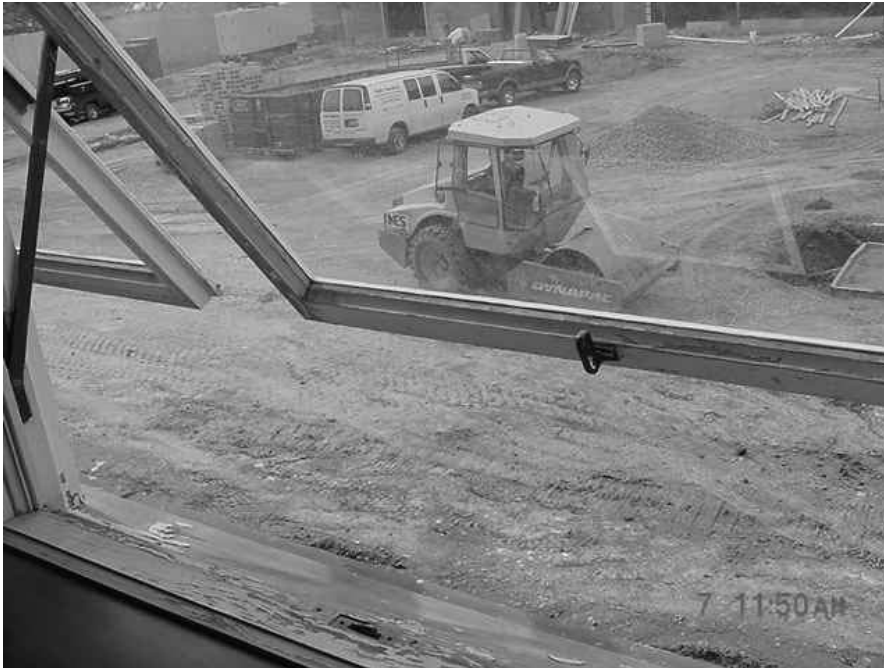
**Picture 10**

A number of construction vehicles and several large piles of dirt/construction debris were observed around the perimeter of the building. This activity should be closely monitored to prevent the entrainment of vehicle exhaust and other construction generated pollutants inside the building via univents, open doors or windows. A number of classrooms adjacent to the construction zone had open windows (Picture 10). The opening of windows allows for unfiltered air to enter the classroom environment carrying with it airborne dirt, dust and particulates. Thus, opening windows should be done with caution. Dusts can be irritating to the eyes, nose and respiratory tract.

**Operating Construction Vehicle outside Classroom 207**

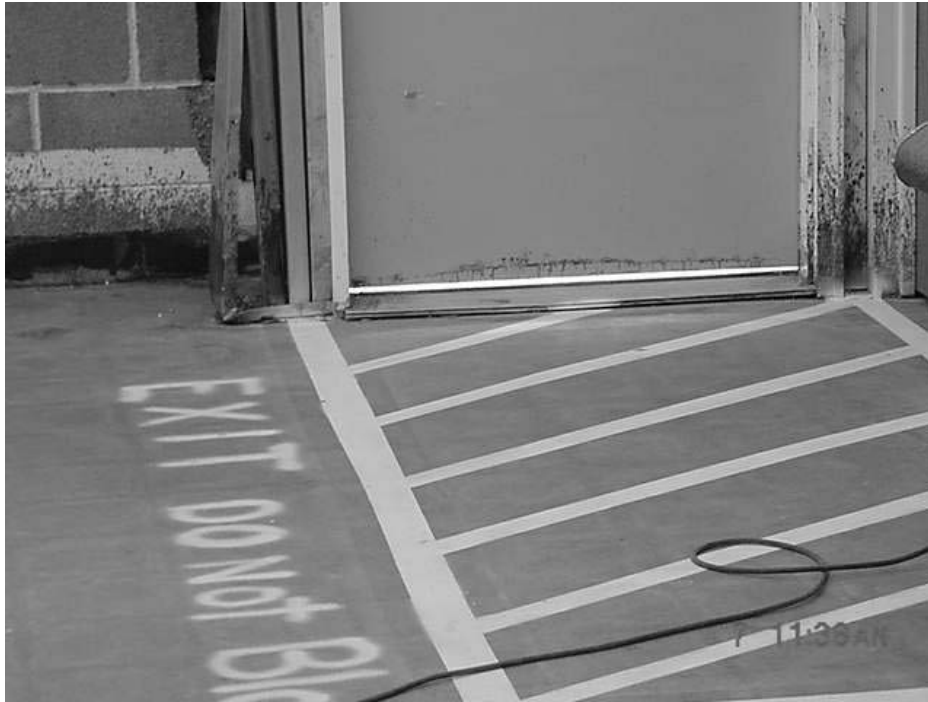
**Picture 11**

Other pathways were observed for construction-generated pollutants to enter occupied areas of the building. A temporary doorway was installed in classroom 5, which is located in the lower level. A gap was noted below the door (Picture 11); several areas around the doorway were open, allowing drafts and light into the room near the top of the doorway (Picture 12). As a result, birds had entered the classroom and built a nest on top of the temporary doorway (Picture 13).

**Space under Exterior Door in Classroom 5, Lower Level**

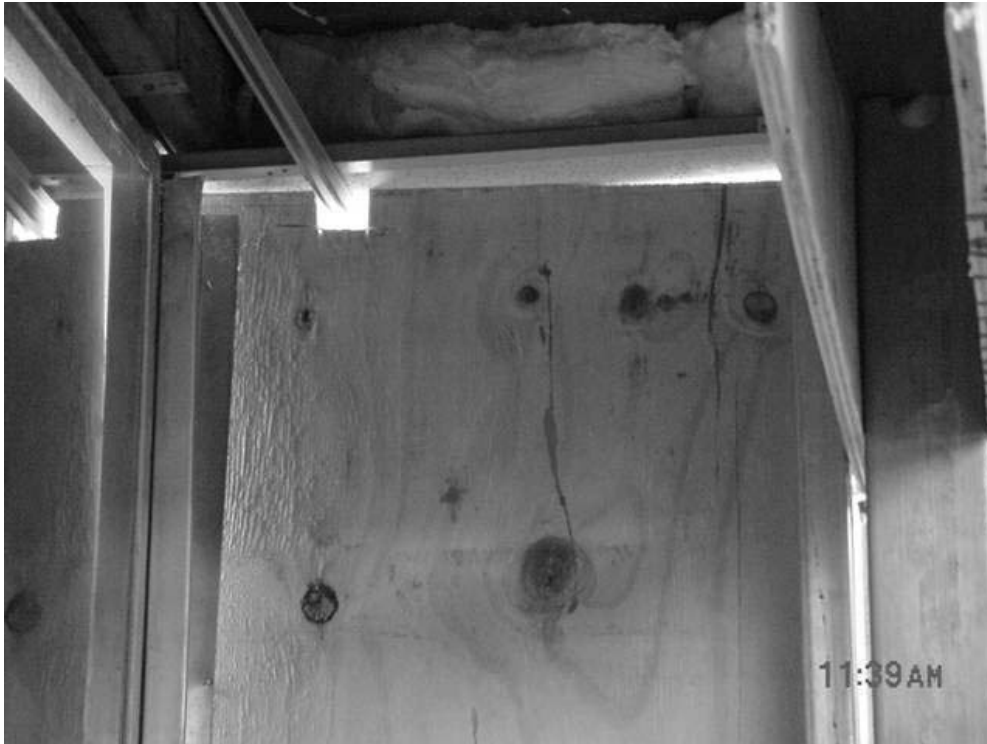
**Picture 12**

**Spaces around Wood for Temporary Doorway in Classroom 5**

6. Seal and insulate the temporary doorway in classroom 5.
7. Remove bird's nest in classroom 5, and disinfect with an appropriate antimicrobial where necessary.

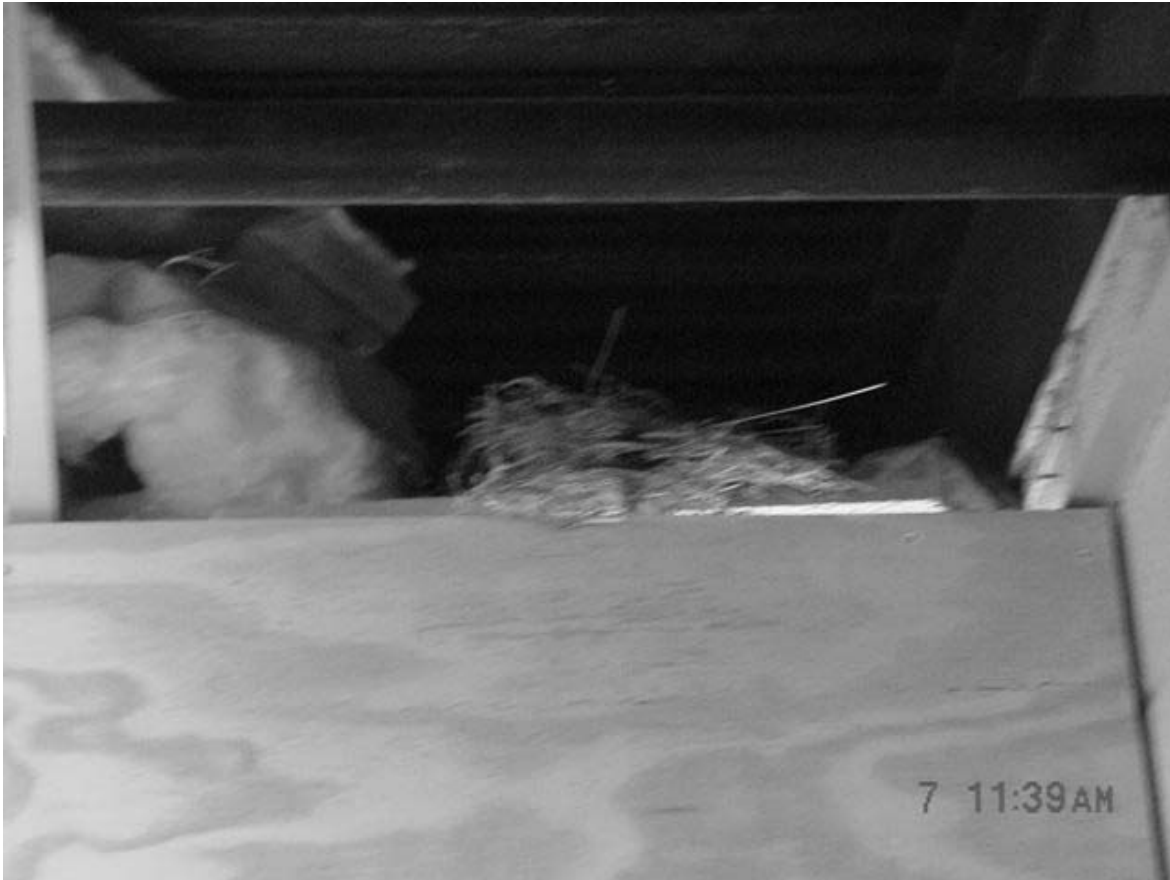
**Picture 13**

**Birds Nest on top of Temporary Doorway *inside* Classroom 5**
